Victa and A.E.S.L. Airtourer Series Aeroplanes

AD/VAT/1

**Nose Wheel Leg Attachment
Angles - Replacement**

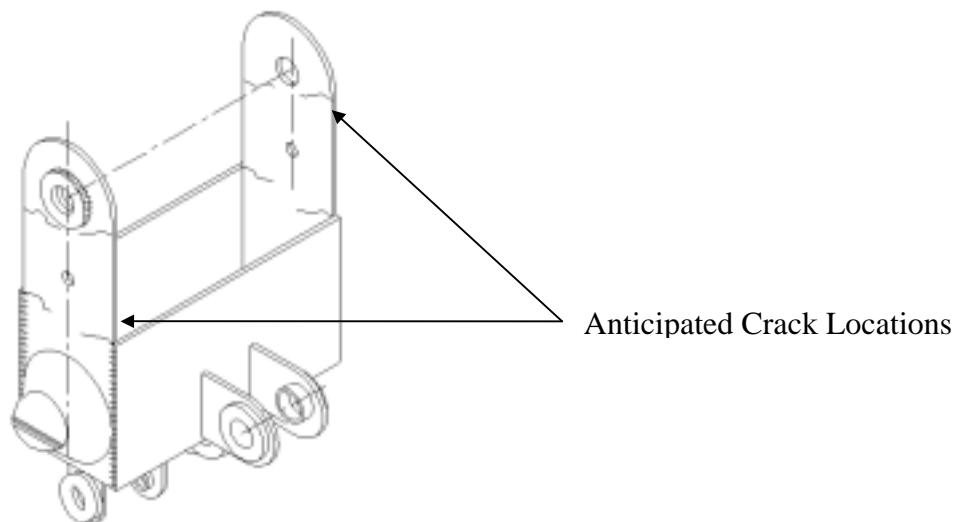
Figure 1

Requirement: 1. Visually inspect both Wagglers attach arms for cracks in accordance with Edge Aviation Service Bulletin EA-AT-2000/001 Issue 1 Section 2. Anticipated crack locations are as indicated at Figure 1.

Background: The original issue of this AD was raised as a result of two instances of control column waggler arm cracking having been found following aileron control malfunction. This amendment is issued as a result of a further case of a seriously cracked waggler, and also to update the AD and require modification of the wagglers rather than indefinite periodic inspections.

2. Modify in accordance with Edge Aviation Service Bulletin EA-AT-2000/001 Issue 1 Section 3 or a modification approved by a CAR 35 Authorised Person.

Note: Wagglers modified in accordance with the initial issue of this AD have waggler arms which have been doubled in thickness by the addition of welded doublers to the outer faces of the side attachment arms. Total thickness of the side attachment arms of modified wagglers should be approximately 0.098" (2.49mm). Wagglers so modified meet requirement 2 of this AD.
